# MPI Fringe Tracker Anomaly

2/21/97

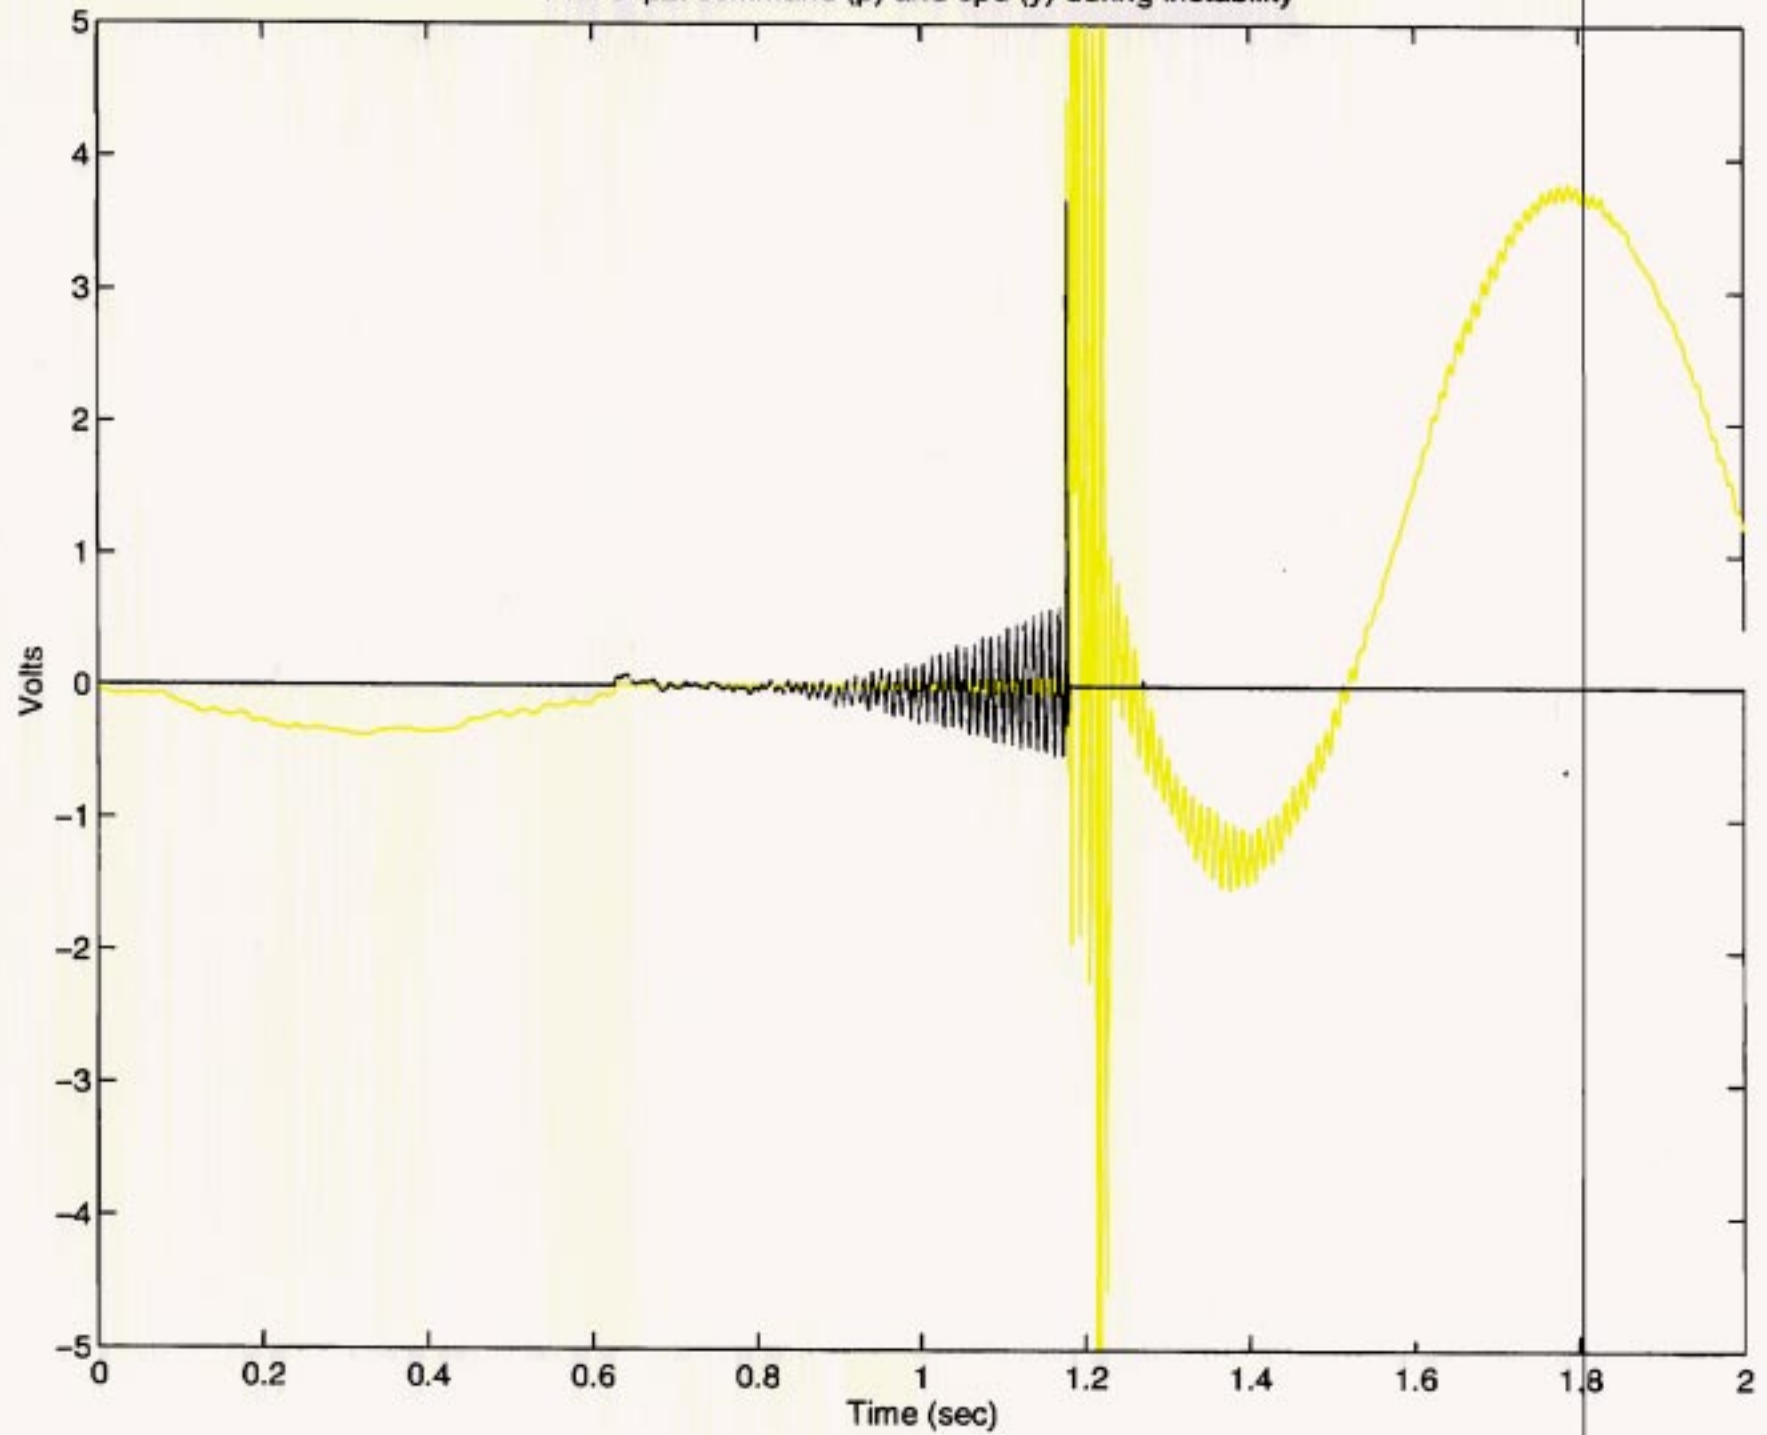
Plot of pzt command (p) and opd (y) during instability

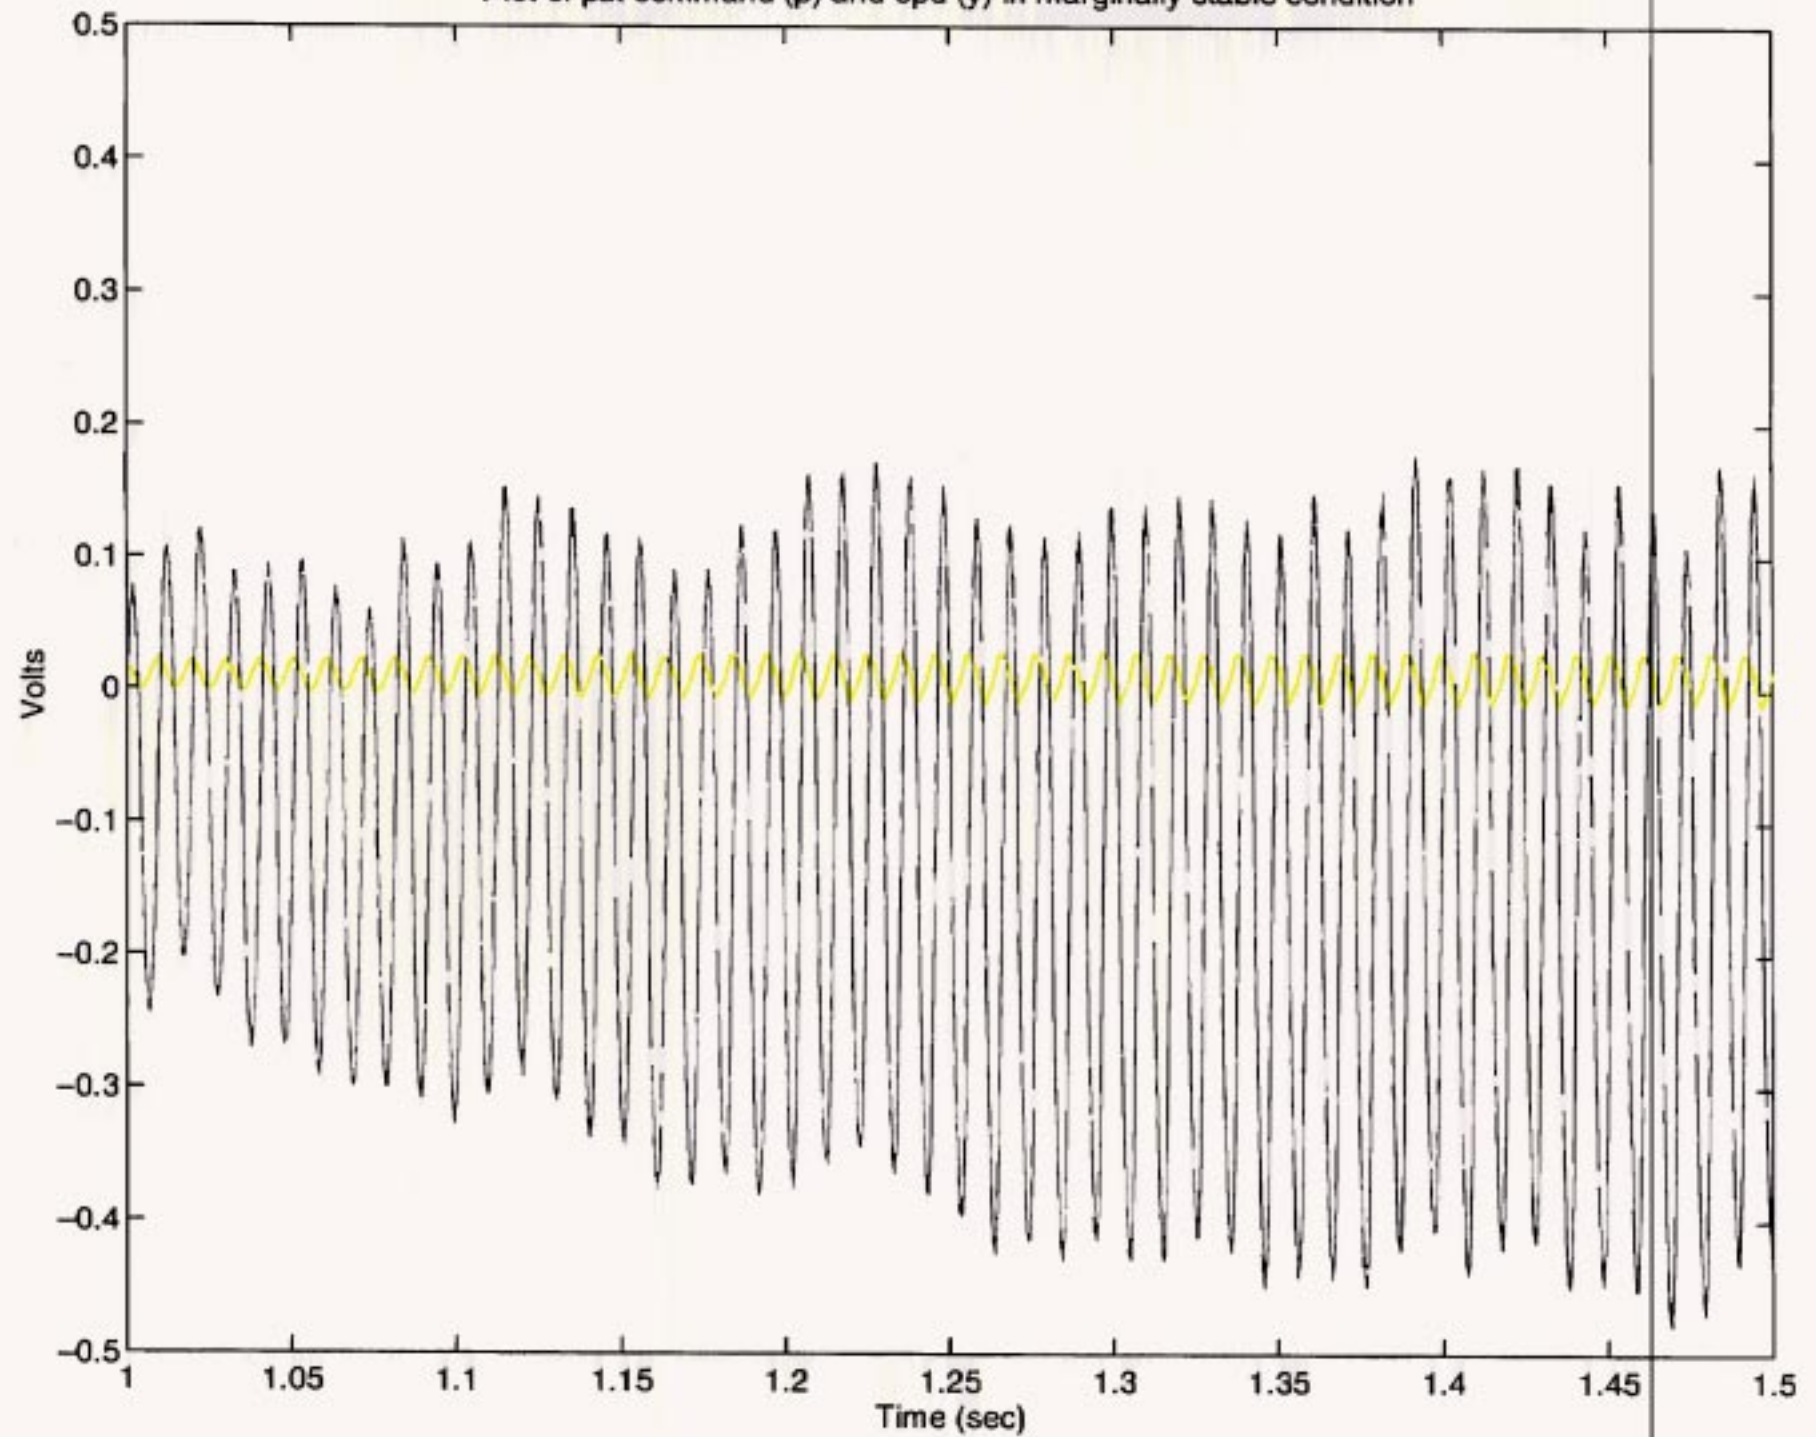
Plot of pzt command (p) and opd (y) in marginally stable condition

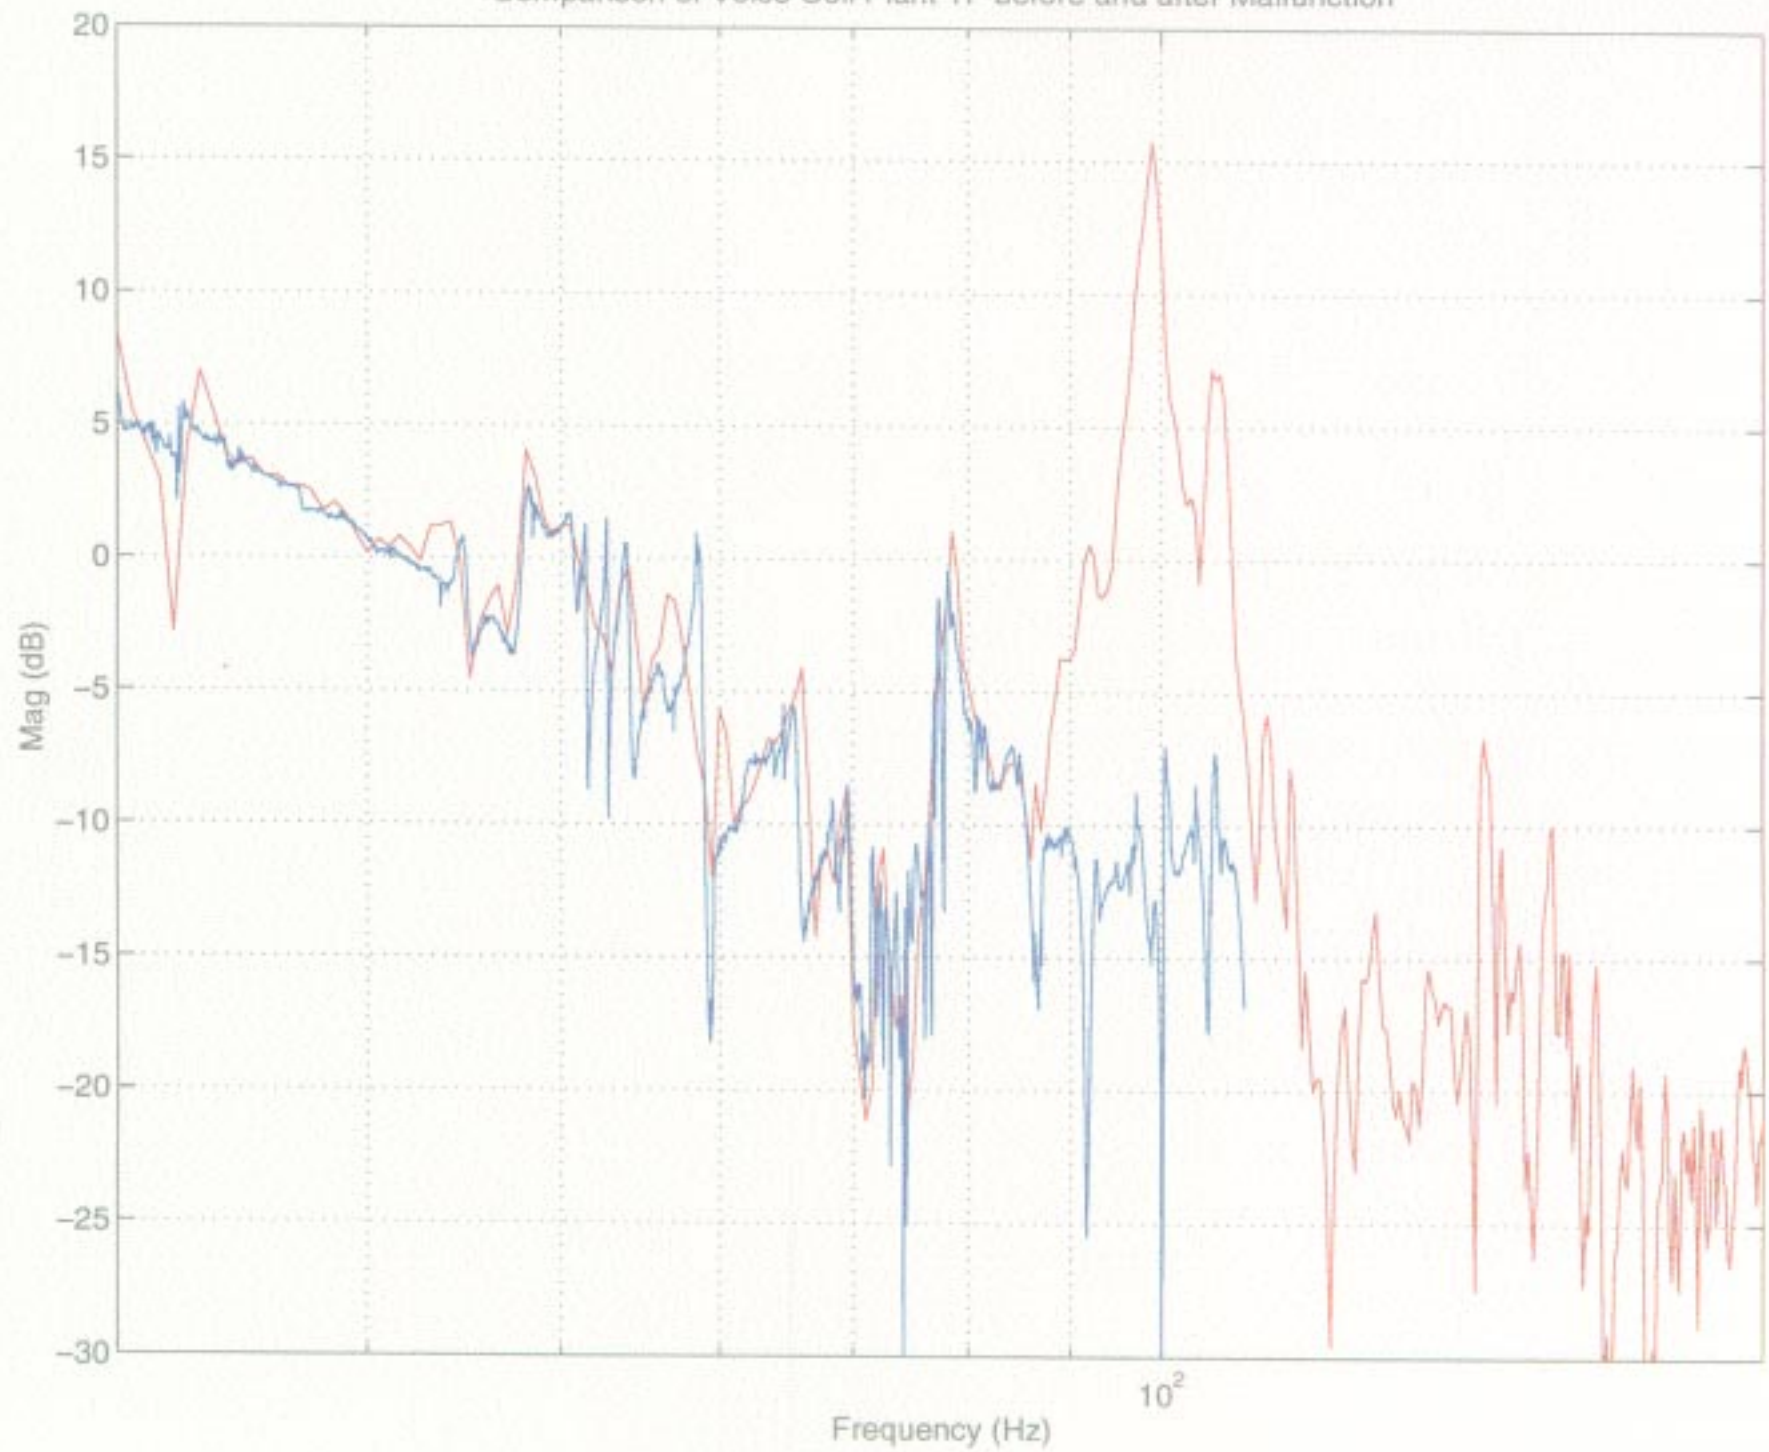
Comparison of Voice Coil Plant TF before and after Malfunction

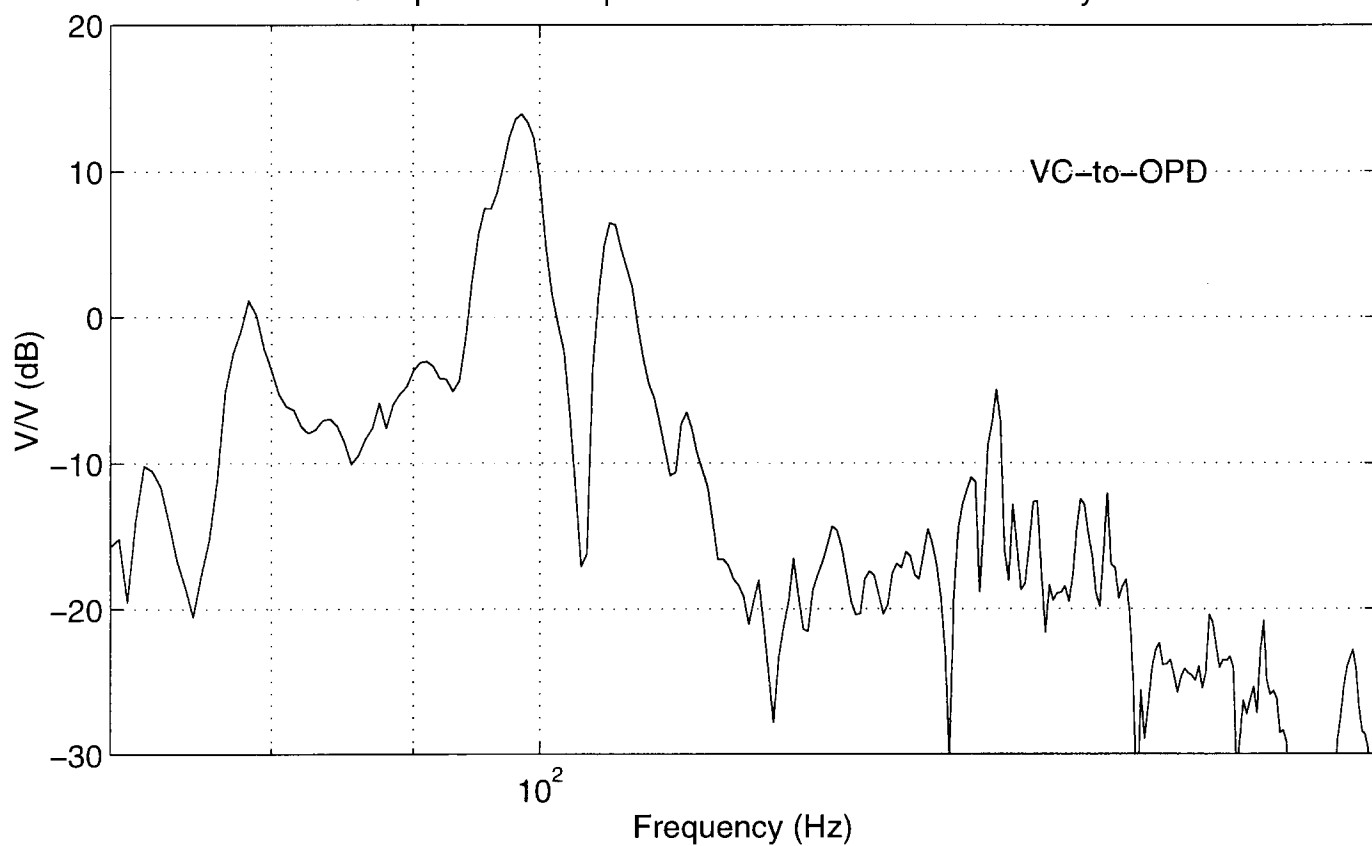
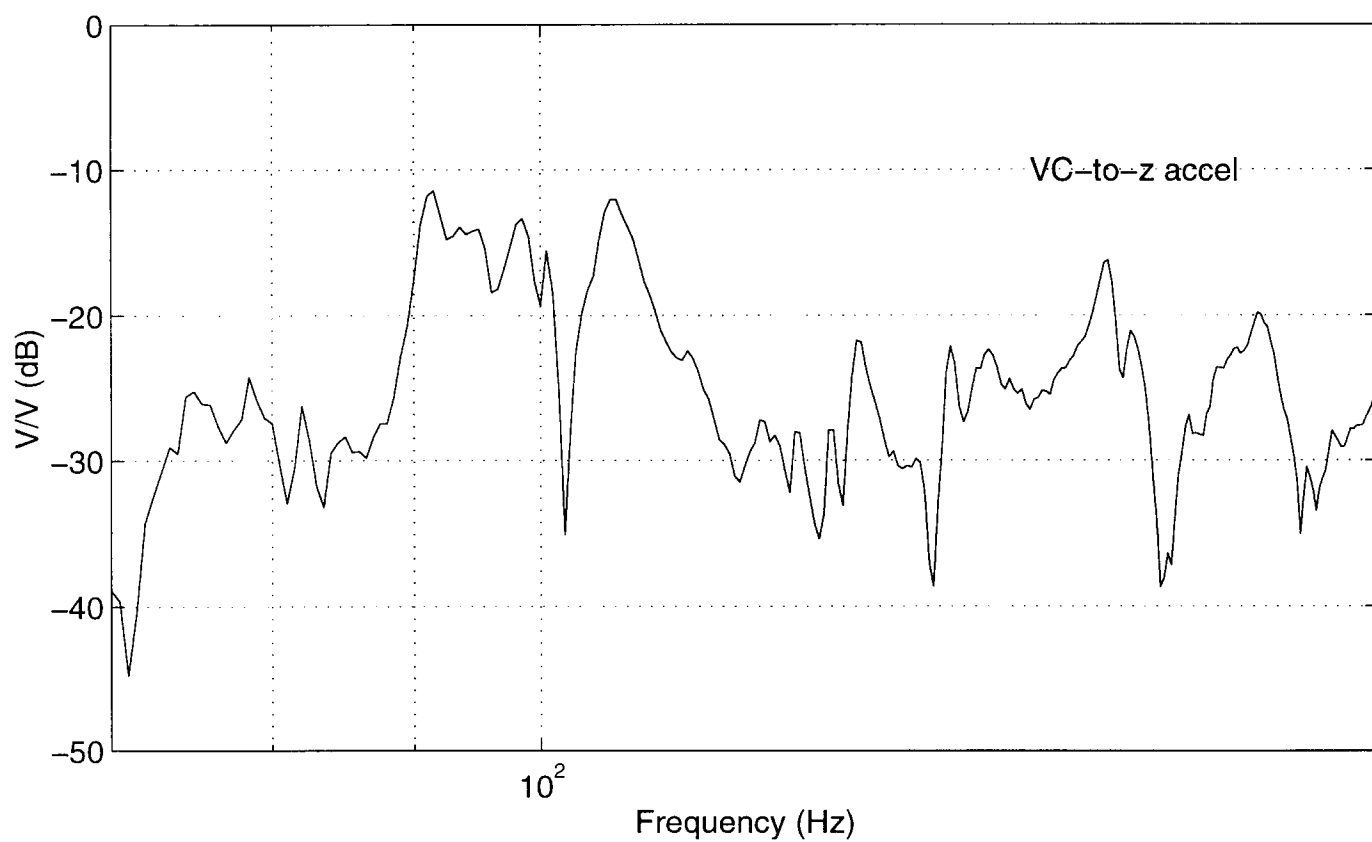
Comparison of vc plant tf to vc-to-z accel on cats eye tf

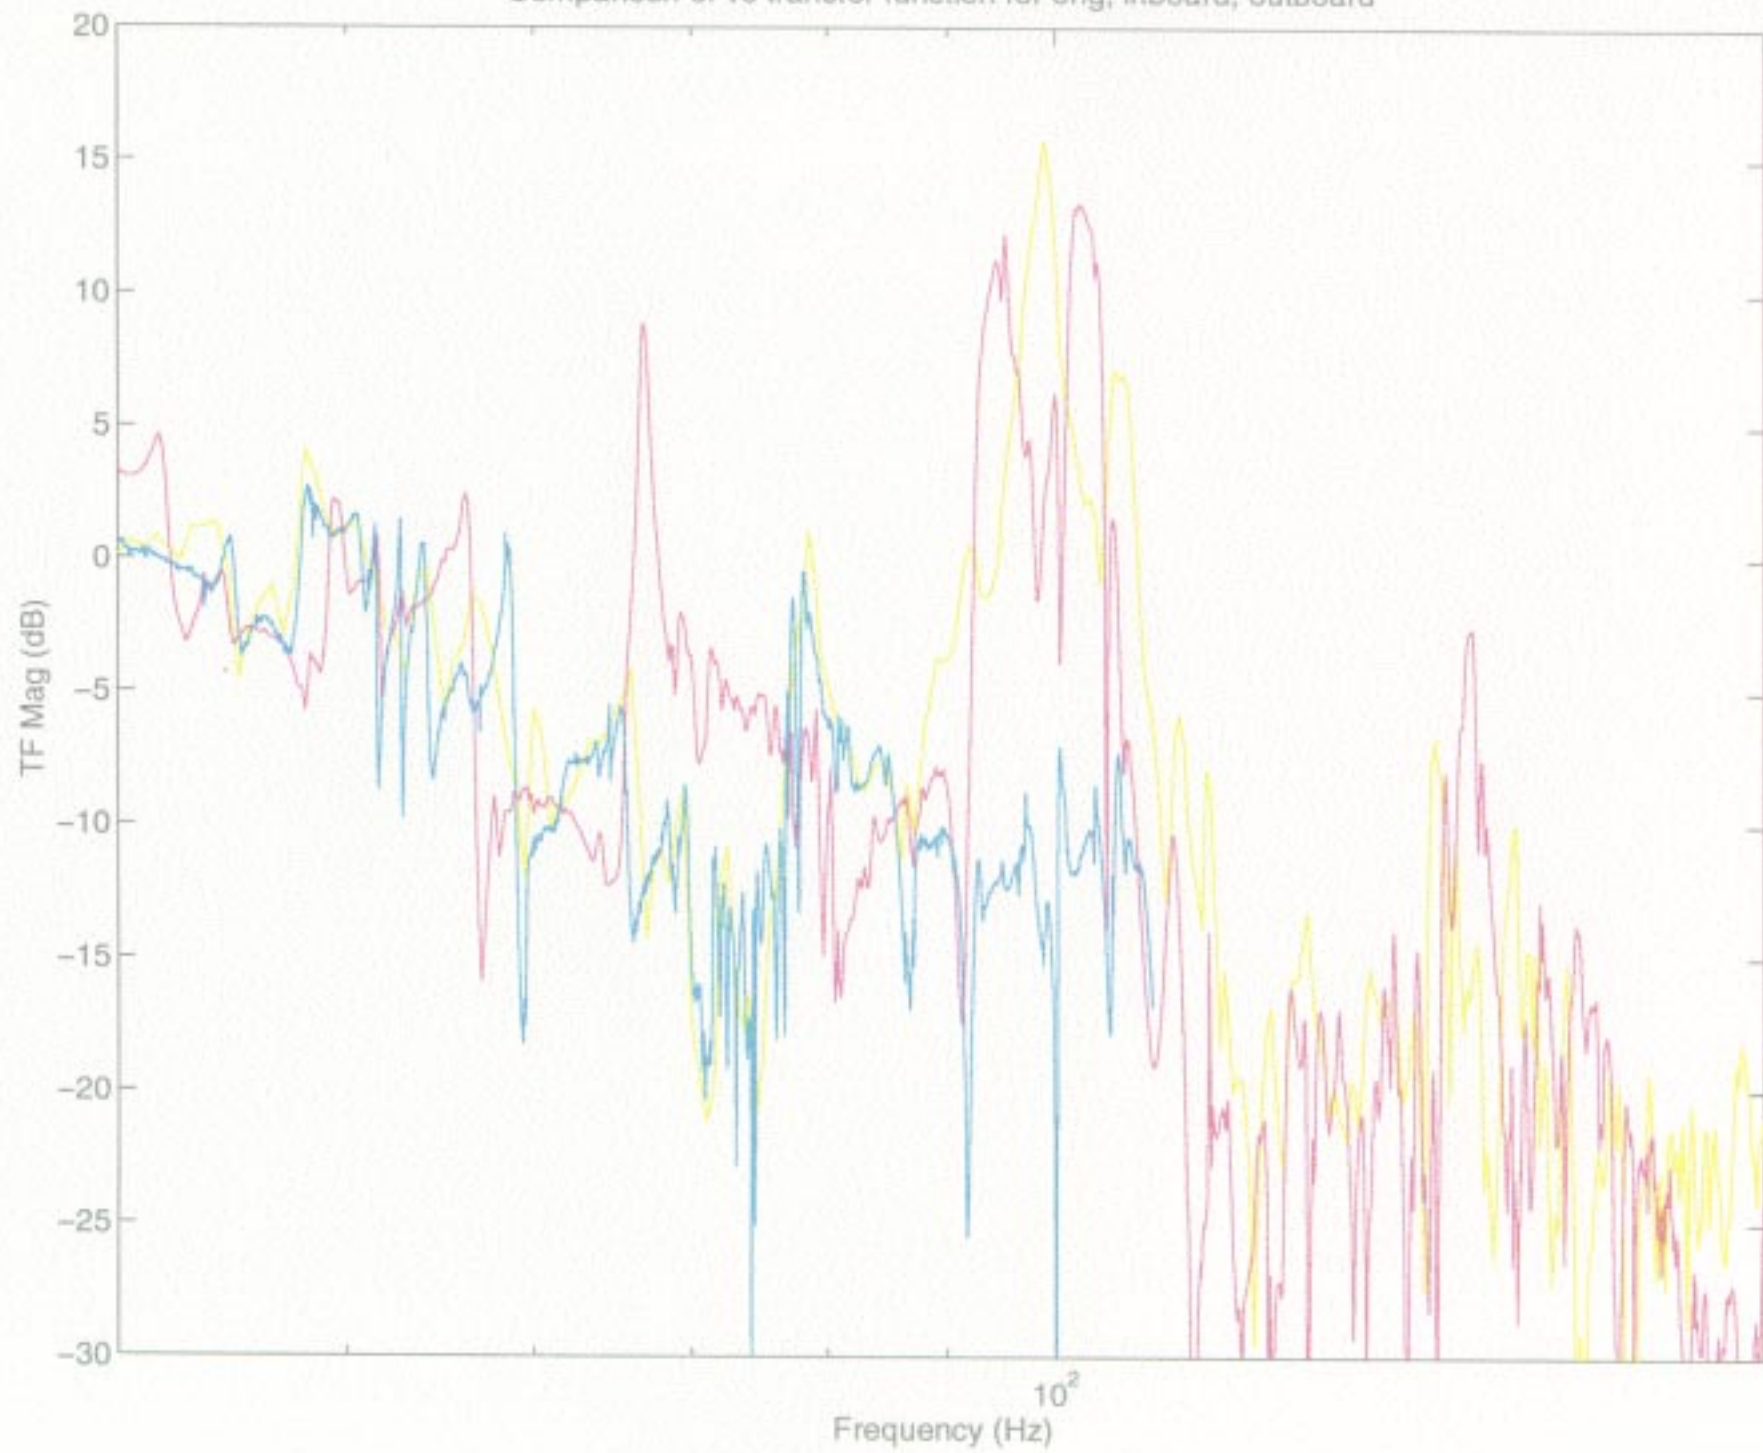
Comparison of vc transfer function for orig, inboard, outboard

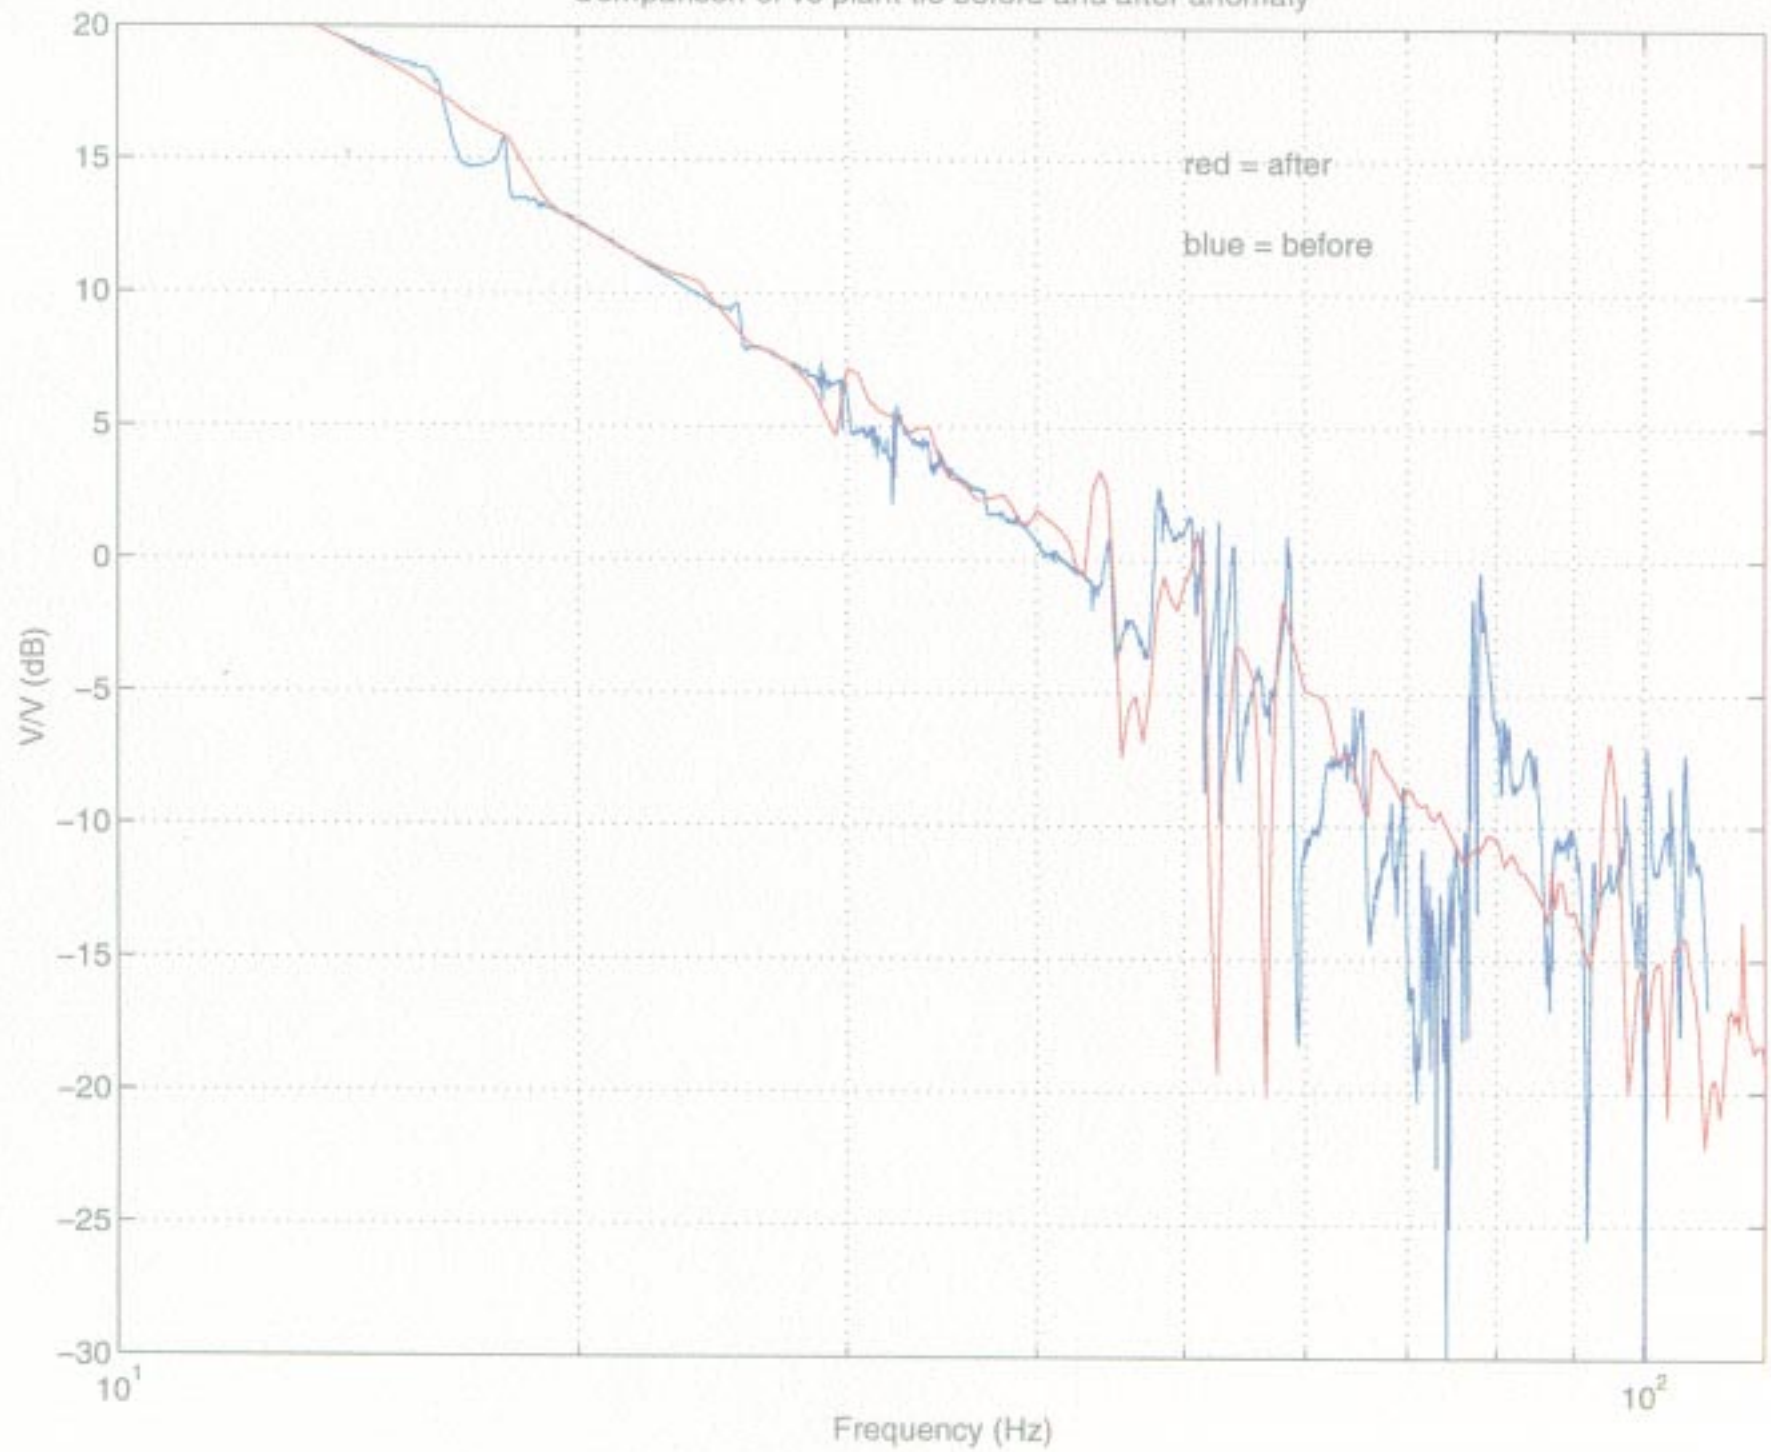
Comparison of vc plant tfs before and after anomaly
